# VAIONT RESERVOIR DISASTER

*Geologic causes of tremendous  
landslide accompanied  
by destructive flood wave*

GEORGE A. KIERSCH, F. ASCE

Professor of Engineering Geology, Cornell University, Ithaca, N.Y.

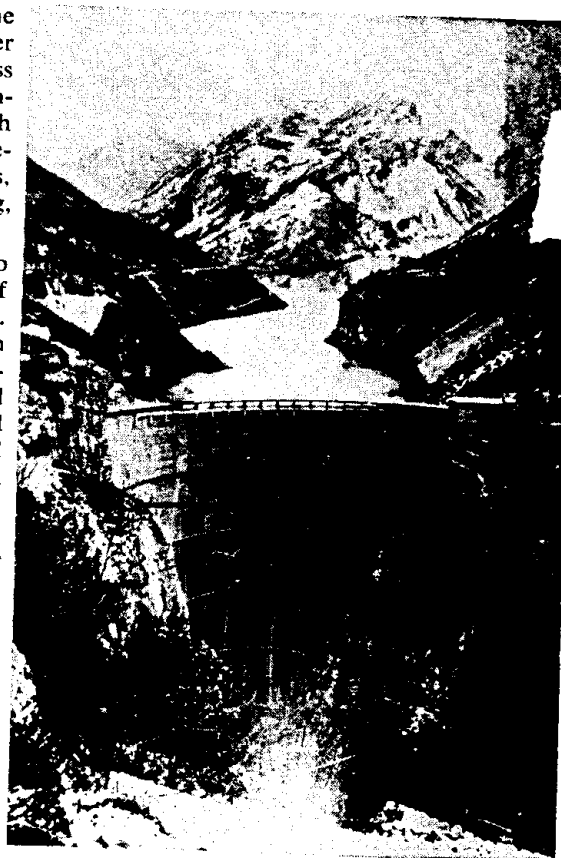
FIG. 2. Completed Vaiont Dam is seen with reservoir at about El. 680 m. On the right of the photograph, the white slope near the dam marks the 1960 slide. All the steep slope beyond was involved in the 1963 slide. (Wide World photo)

In 1960, a slide of some 1 million cu m (1.3 million cu yd) occurred on the left bank of the reservoir near the dam. (See Figs. 1, 2, and 3.) This movement was accompanied by creep over a much larger area: a pattern of cracks developed upslope from the slide and continued eastward.<sup>10</sup> These fractures (Fig. 1) ultimately marked the approximate limits of the October 9 slide. The slopes of Mt. Toc were observed to be creeping and the area showed many indications of instability.<sup>9</sup>

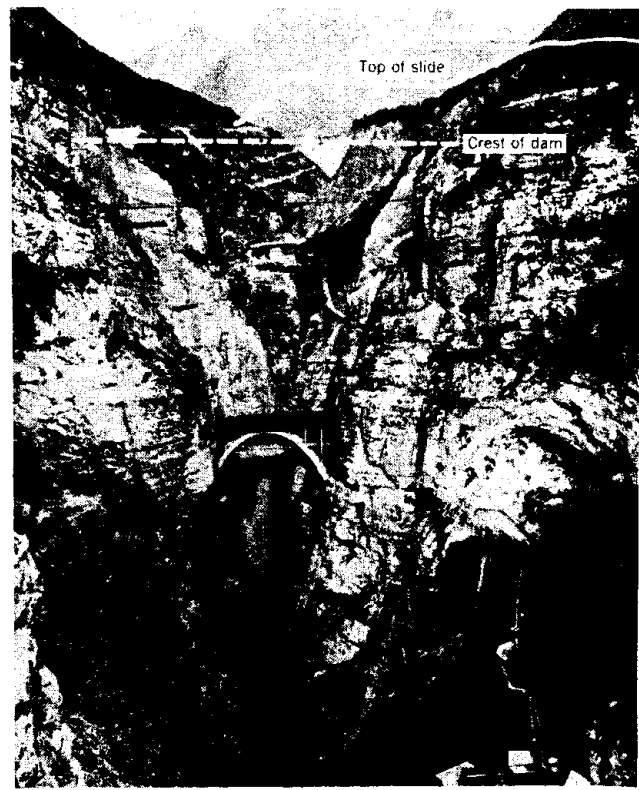
FIG. 3. Vaiont canyon is seen looking toward the reservoir site during early construction and stripping of abutments. Terrain of 1960 and 1963 slides is shown at right, with the steep cliff of Malm formation. The overtopping flood wave scoured the abutments above the dam, destroying the aqueduct and bridge (black) and stripped away the highway, lower right. Photo courtesy of Water Power.

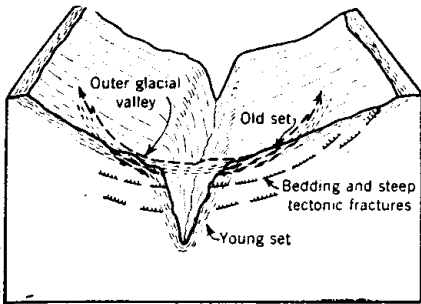
The development of rebound joints beneath the floor and walls of the outer valley is shown in Fig. 4. This destressing effect creates a weak zone of highly fractured and "layered" rock, accentuated by the natural dip of the rock units. This weak zone is normally 100 to 150 m (330 to 500 ft) thick. Below this a stress balance is reached and the undisturbed rock has the natural stresses of mass.

ner valley (Fig. 4). This sector of the canyon walls, weakened by overlapping rebound joints, along with abundant tectonic fractures and inclined bedding planes, is a very unstable rock mass and prone to creep until it attains the proper slope.

Steep profile of the inner canyon walls offers a strong gravity force to produce visco-elastic, gravitational creep and sliding (Fig. 4).

FIG. 4. On sketch of inner Vaiont canyon and remnants of the outer glacial valley, are shown rebound joints—old and young set—from stress relief within the walls of the valley to depths of 100 to 150 m (330 to 500 ft).

Two sets of strong rebound joints, combined with inclined bedding planes and tectonic and natural fracture planes, created a very unstable rock mass throughout the upper part of the inner canyon (Fig. 4).

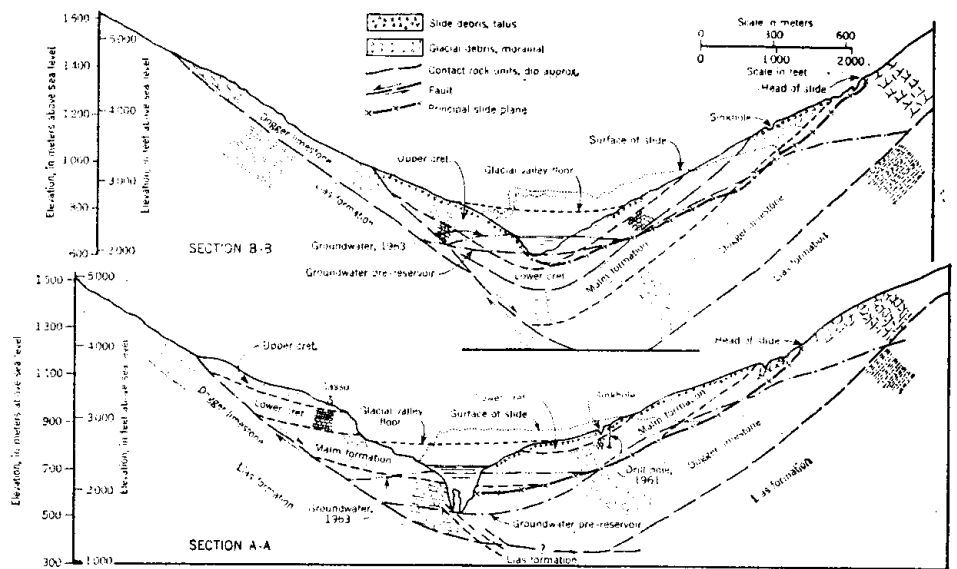
Heavy rains for two weeks before October 9th produced an excessive inflow of ground-water from the drainage area on the north slopes of Mt. Toc. This recharge raised the natural ground-water level through a critical section of the slide plane (headward part) and subsequently raised the level of the induced water table in the vicinity of their junction (critical area of tensional action). The approximate position of both water levels at the time of the slide is shown in Fig. 5.

FIG. 5. On geologic cross-sections of slide and reservoir canyon, running from north to south, principal features of the slide plane, rock units and water levels are shown. For location of Sections A-A and B-B, see Fig. 1.

beds created additional uplift and contributed to sliding. The upstream sector (Fig. 5, Section B-B) is composed largely of marl and thin beds of limestone with clay partings—a rock sequence that is inherently less stable than the downstream sector (Fig. 5, Section A-A).

Construction of Vaiont Reservoir created an induced ground-water level which increased the hydrostatic uplift pressure throughout a triangular subsurface mass (Fig. 5) aided by fractures and the interconnected system of solution openings in the limestone.

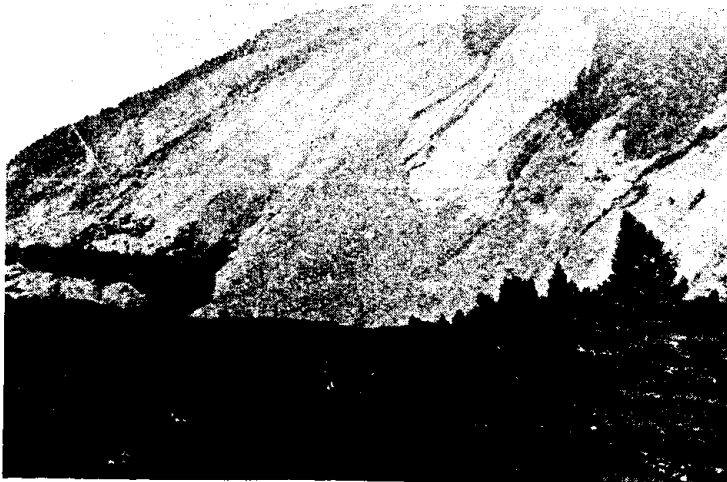
FIG. 7. Top of main slide is seen along cross section A-A of Fig 5. Typical talus runs and step-like blocks are shown moving down the surface of the slip plane. The coherent grass and soil, characteristic of a large part of the surface of the slide mass, appear in foreground.

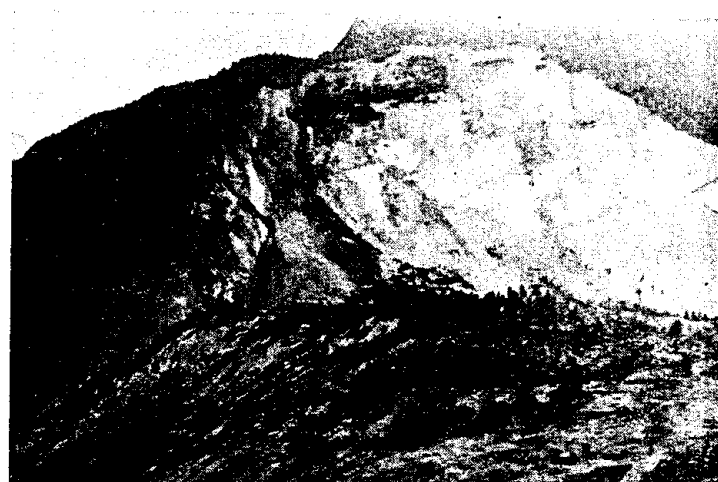
FIG. 8. Slip plane and eastern limit of the slide are seen looking south from a point above the former reservoir. A typical slide mass is in foreground, with talus runs and step-like blocks moving down the slip plane.

main slip plane (Fig. 8). These blocks were loosened by the movement on October 9 and have since moved slowly down the slip plane, some to the bottom of the escarpment. Talus runs are common from small V-notched canyons along the edge of the steep eastern sector of the slide.

The steeply dipping beds along the head of the slide will undoubtedly fail from time to time as a result of gravitational creep. Ultimately the uppermost part of the slip plane (Fig. 8) will be flattened and thereby will attain a stable natural slope.

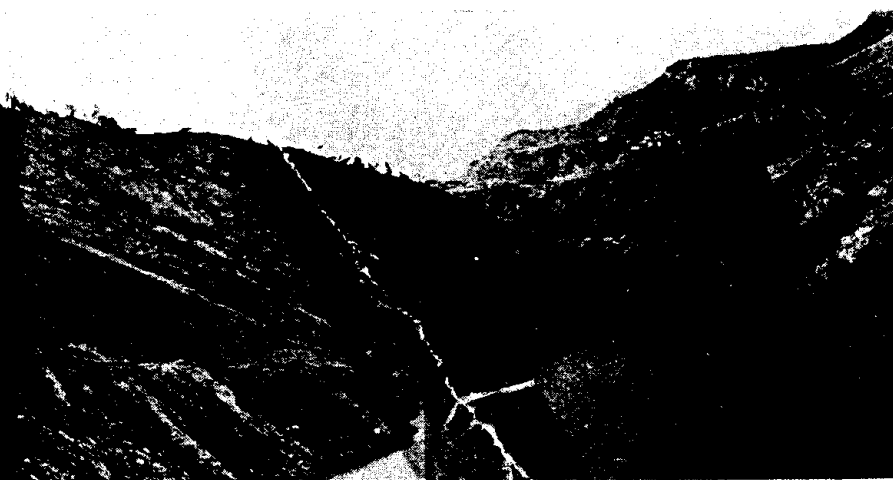
FIG. 9. Upstream side of slide "dam" and impounded reservoir are seen looking westward from near Pineda. Note village of Casso at upper right center (El. 960 m). Low "rift" valley in center of photo is due to settling and lateral slipping of slide mass within the reservoir canyon.
