# Critical Review of the Root Cause Investigation of Crystal River Delamination

DECEMBER 2019

VICTOR E. SAOUMA

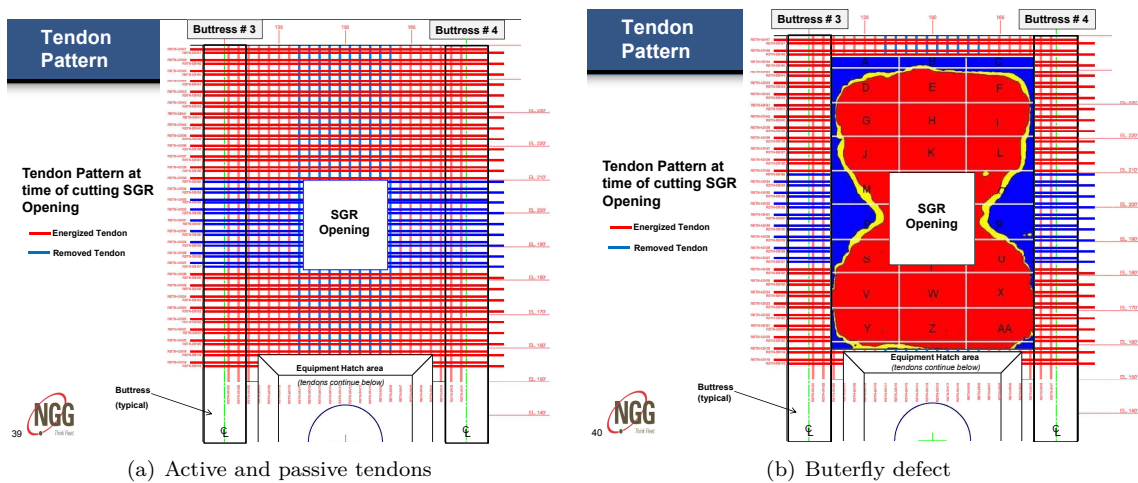
Figure 6: Tendon pattern (Progress Energy Florida (ML102861026), 2009)

In the process of cutting such an opening in the concrete containment wall a concrete separation condition was discovered, Fig. 7(a). It was located approximately in the cylindrical plane of the centerline of the hoop tendons, approximately nine to twelve inches from the exterior surface of the containment building and had the shape of a butterfly Fig. 6(b).

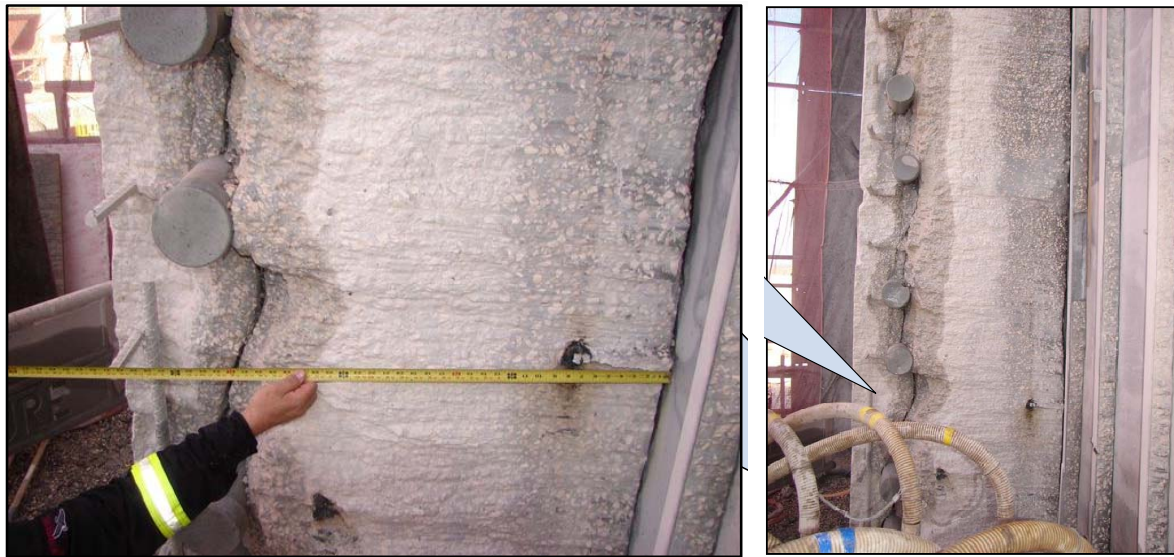
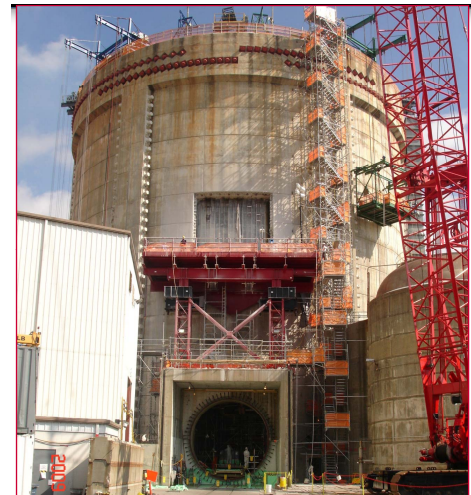
Figure 7: Delamination of Crystal River (Progress Energy Florida (ML102861026), 2009)

Approximately 30 inches of concrete remained in apparent good condition all the way to the liner plate. The hydro-demolition of the concrete continued when the containment building liner was exposed and all concrete had been removed down to the liner, Fig. 7(b).

The licensee's investigation concluded that the delamination was caused during the creation of the opening in containment, Fig. 7(c). As part of preparing the containment building for making the opening, tendons

in the containment building wall were detensioned. The main cause of the delamination was attributed to the scope and sequence of this tendon detensioning. Tendon detensioning began after the plant was shut down in Operating Mode 5, when containment operability was not required.

The licensee found that the delamination was centered on the steam generator opening and formed the shape of an hour-glass. The delamination was limited to the containment bay between buttresses 3 and 4, and did not affect other bays of containment. The licensee's repair plan to remove and replace the delaminated condition included: (1) additional detensioning of containment; (2) removal of delaminated concrete; (3) installation of reinforcement, including radial reinforcement through the delamination plane; (4) placing of new concrete; (5) retensioning containment; and (6) post-repair confirmatory system pressure testing.

(a) Delamination

(b) Exposed liner

(c) Delamination explained

(d) Steam Generator Replacement opening (between buttresses 3 and 4)

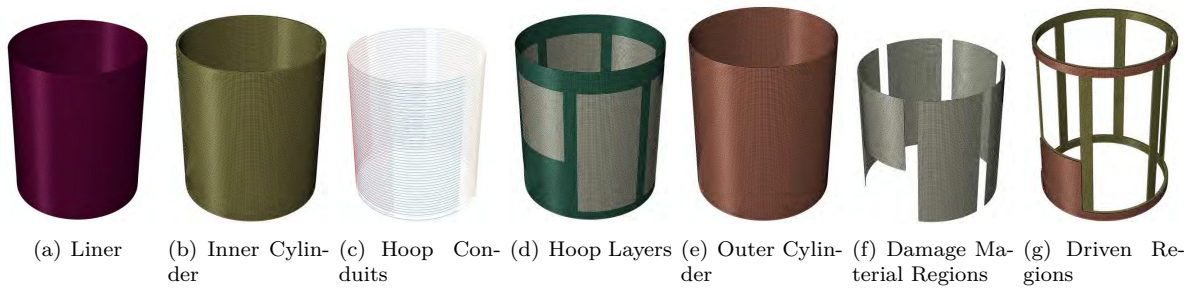
Figure 8: Group 7 Finite element analyses; global sub-model (ADAMS Accession No. ML 102861026, 2010)

**Hoop Layer** is a 5.25" thick layer which encompasses the vertical and horizontal sleeves. It is modelled by *solid elements with damaged plasticity material property based on the Lee-Fenves model (Lee and Fenves, 1998)*. These regions are allowed to crack and potentially to delaminate. The green regions are not allowed to crack since those regions are reinforced with steel. Fig. 8(d).

**Damage Material Regions** regions of the hoop layer which has the concrete damage plasticity material properties. These regions are allowed to crack and may result in delamination of the outer cylinder from the inner cylinder. Fig. 8(f).

**Driven Regions:** The region is driven by the displacements from the global model. The displacements are synchronized with the loadings in the delamination model. Hence, the global effects due to tensioning, creep, and SGR detensioning (including the unloading of the 10 vertical tendons) are accounted for., Fig. 8(g).

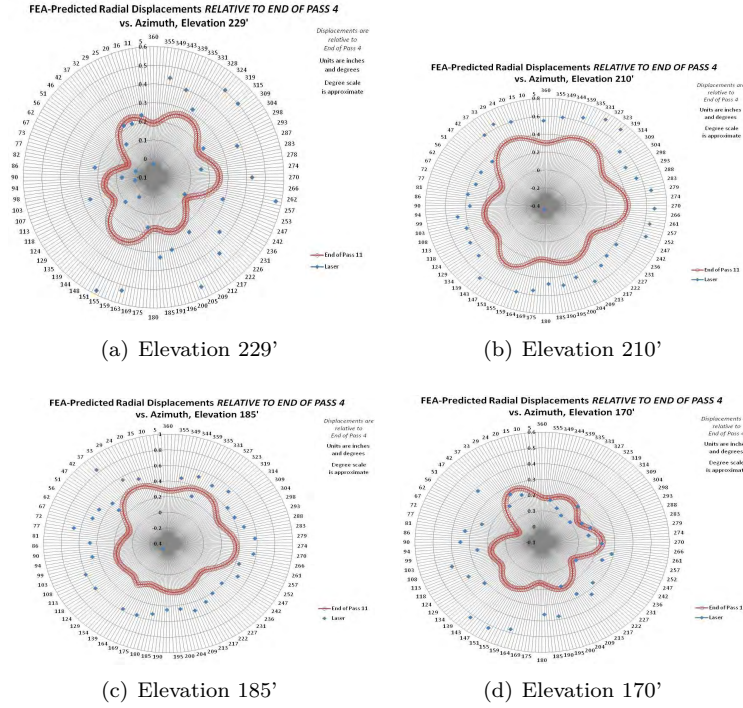
Figure 11: Comparison of PII computer model predictions for radial displacement from pass 4 through pass 11 at various elevations to the laser scanning data (ADAMS Accession No. ML 102861026, 2010)

Benchmarking results was preceded by the same comments as in Sect. 2.1 with regard to Abaqus, NASTRAN and material properties. Results, with the 1976 Structural/System Integrity Test (SIT) is shown in Fig. 10, and those with the interior laser scanning performed in 2010 during detensioning in Fig. 11. It should be noted that laser scanning was performed after each group of tendons (referred to as a Pass) was de-tensioned from after Pass 4 until after Pass 11. Pass 4 was taken as the baseline for all the readings so the Pass 11 data represents the change in radial displacement from Pass 4 through Pass 11.

“Benchmarking” of the code results are inconclusive at best. SIT (in theory) should not have induced any nonlinearity (cracking or otherwise), hence excellent correlation between measurements and computations should be expected. Indeed adequate correlation is reported, however this does not necessarily validate the code for nonlinear analyses.

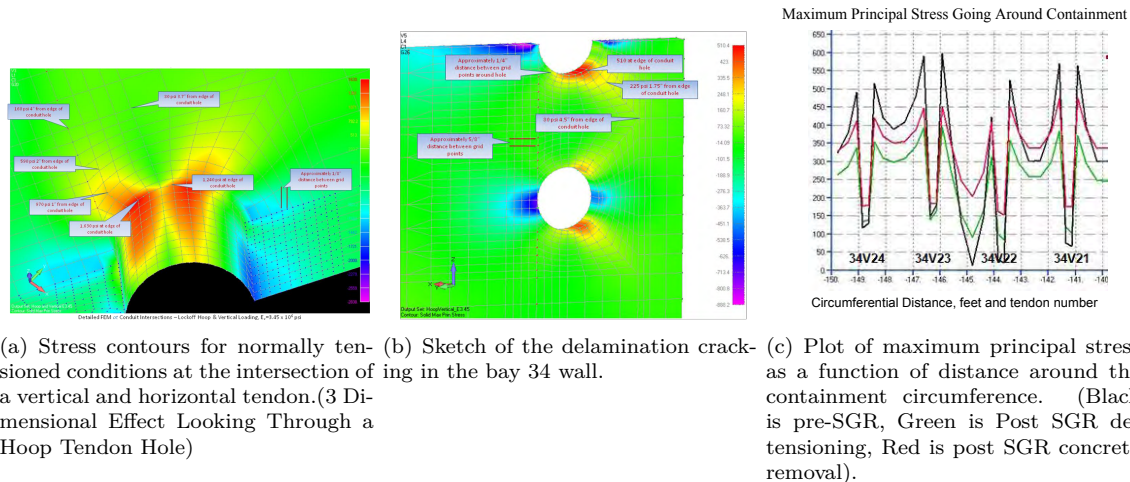
Figure 12: Group 1 Finite element Analyses (ADAMS Accession No. ML 102861026, 2010)

On the basis of Fig. 12(a), PII points to the *peak tensile stress at the edge of the horizontal tendon hole near a vertical tendon is well in excess of the tensile capacity of the CR3 concrete. It is likely that small cracks formed at these intersections but then stopped propagating when they reached a location where the stress was too low to continue..* This is further illustrated by Fig. 12(c).

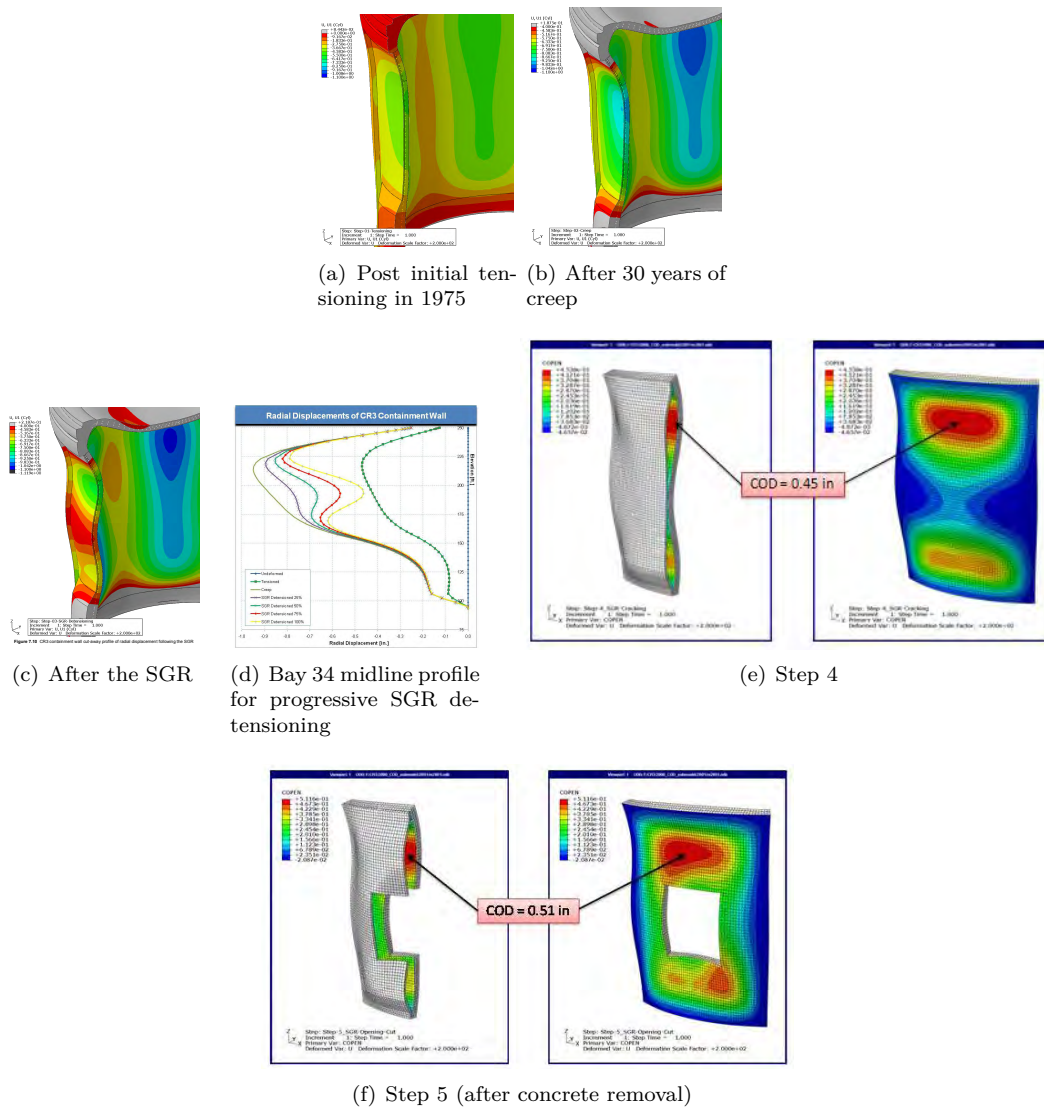
Figure 14: CR-3 bay 34, cracking and crack opening displacement (ADAMS Accession No. ML 102861026, 2010)

Figs. 14(a) to 14(c) show the (displacement) contour lines of the global model (subjected to a linear elastic analysis) at various stages. Fig. 14(d) is a plot of bay 34 midline profile at various stages. Delamination is observed in Fig. 14(e) and 14(f) right before concrete removal and after concrete removal. Displacement contour lines in Fig 14(e) is compared to the field observed extent of cracking shown in Fig. 15.

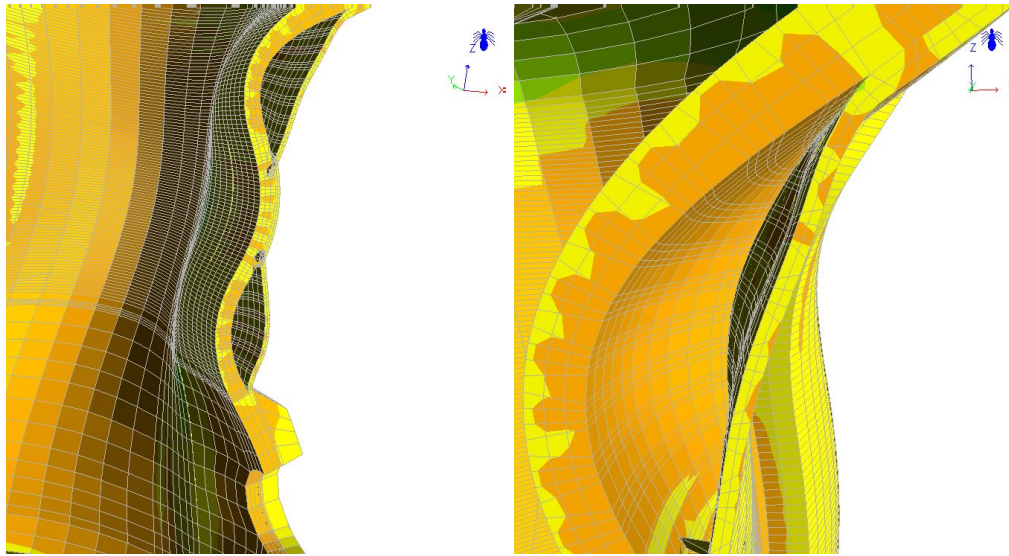
Figure 23: Delamination of CR captured by a fracture mechanics based approach

Fig. 23(a) shows the global response (with highly amplified deformation) of the CEB, whereas closeups on the captured delamination are shown in Fig. 23(b). We note the impact of the individual hoop tendons.

(a) Global response

(b) Delamination details

It is the author's opinion that delamination was caused by the abrupt change in curvature due to the detensioning of the cables inside the SGRO, i.e. not enough cables were detensioned as reported by Tampa Bay Times (2014). This could have been prevented should the tendons right outside the SGRO have been detensioned also in order to minimize abrupt curvature changes.

The simple, yet elegant, fracture mechanics based approach was capable of fully capturing the delamination of Crystal-River.
