# VAIONT RESERVOIR DISASTER

*Geologic causes of tremendous  
landslide accompanied  
by destructive flood wave*

GEORGE A. KIERSCH, F. ASCE

Professor of Engineering Geology, Cornell University, Ithaca, N.Y.

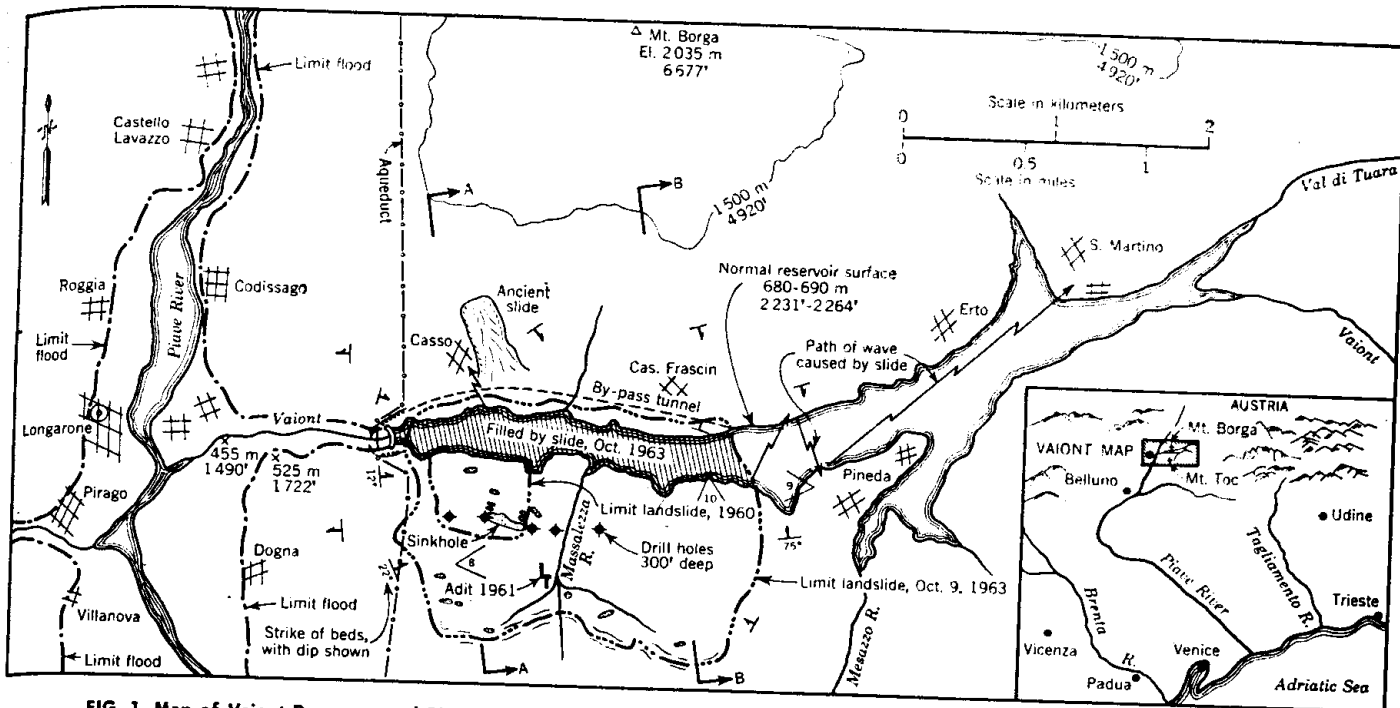
FIG. 1. Map of Vaiont Dam area and Piave River valley shows geographic features, limits of slide and of destructive flood waves.

The result has been subsurface development of extensive tubes, openings, cavities and widening of joints and bedding planes. Sinkholes formed in the floor of the outer valley (Fig. 1), particularly along the strike of the Malm formation on the upper slopes (Fig. 5): these served as catchment basins for runoff for recharge of the ground-water reservoir. This interconnected ground-water system weakened the physical bonding of the rocks and also increased the hydrostatic uplift. The buoyant flow reduced gravitational friction, thereby facilitating sliding in the rocks.
